# Y.I.C. Technologies

## Comprehensive Application Note

### Finding EMC leakage in cables and connectors

April 2024

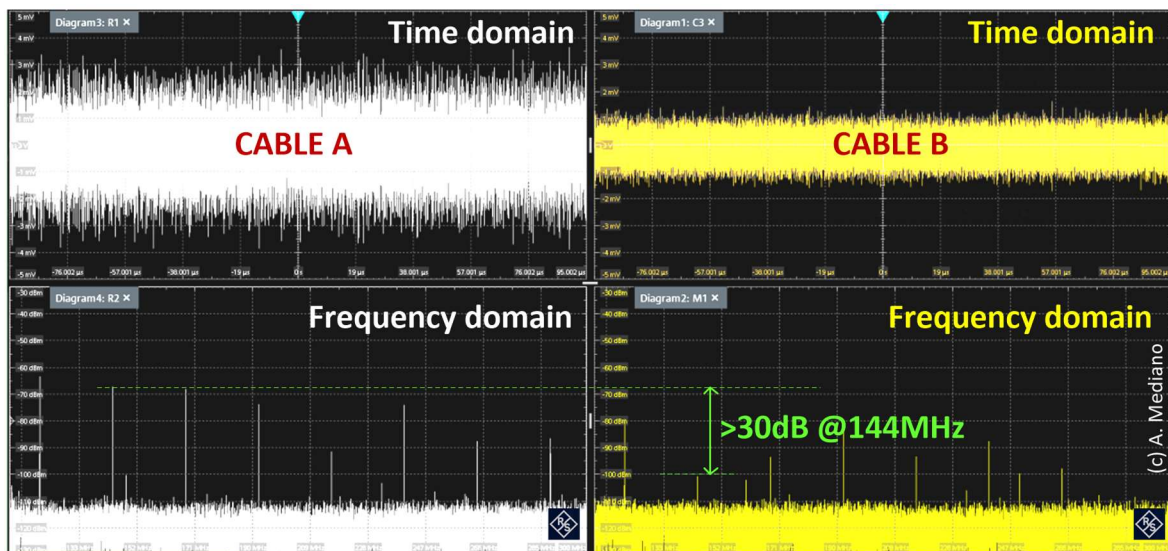
Fig. 3. Measurement of common-mode current in the cables (100-300MHz).

The results in the time domain clearly show a significant difference in the amplitude of the common-mode current flowing through both cables.

It is interesting to observe in the frequency domain that within the range of 100MHz to 300MHz, certain harmonics experience a reduction of more than 30dB (as exemplified by the case at 144MHz in the figure) when using either a good (cable B) or bad (cable A) cable. This reduction of 30-40dB is the primary reason why one cable passes the tests (cable B) while the other does not (cable A).

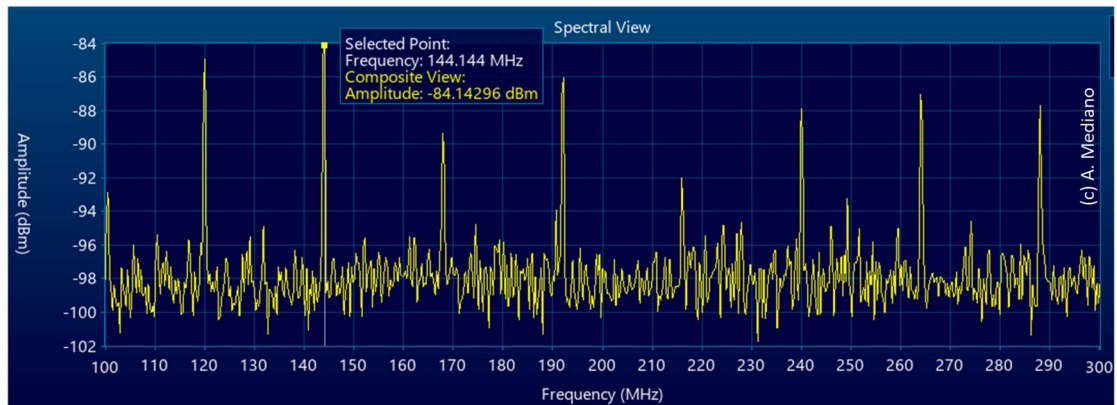
Fig. 5. Spectral scan from the two cables in Fig. 4.

The clock harmonics are clearly visible with a peak at the frequency of 144MHz in the spectral analysis.

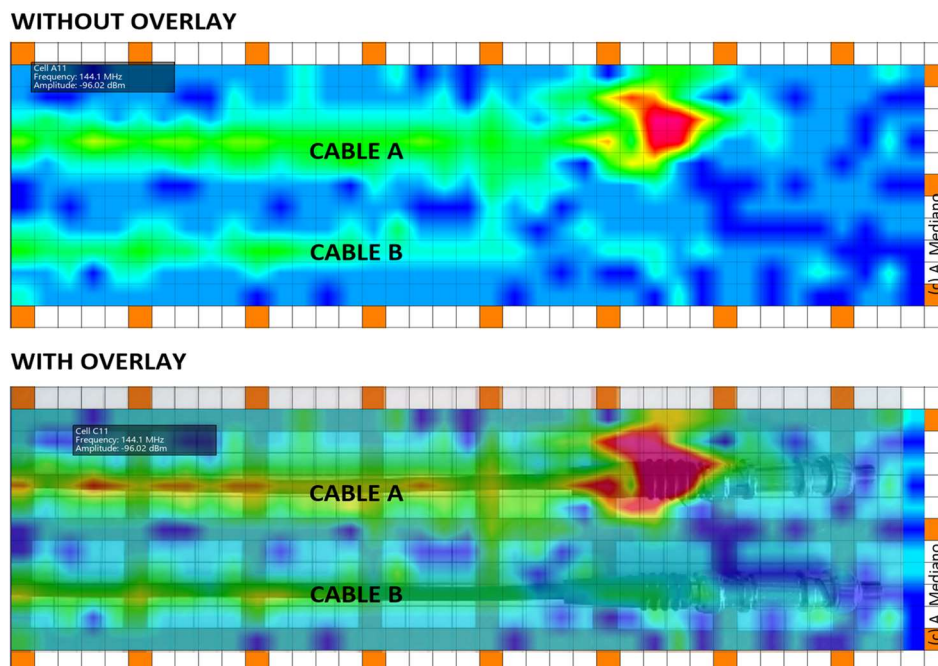
For this frequency, a spatial analysis was conducted, and it was found that cable A exhibited an anomaly (leak) at the connection point to the BNC connector (Fig. 6):

Fig. 6. Spatial scan at 144MHz (2D).

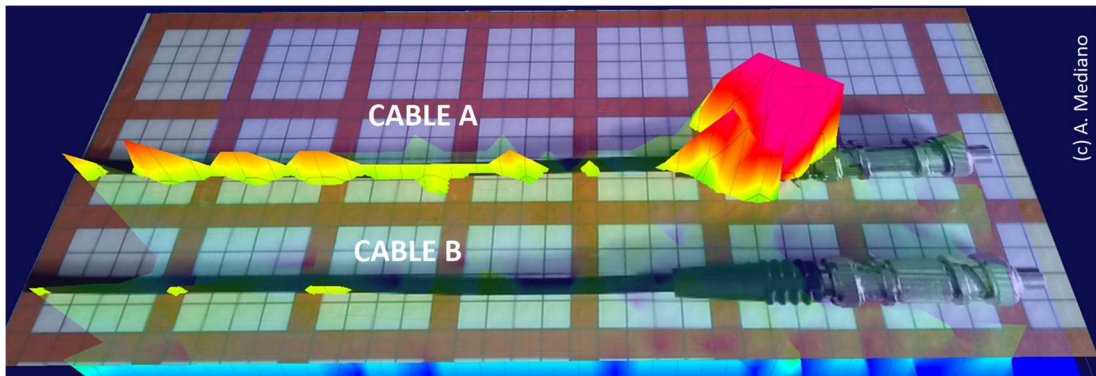
A 3D visualization provides a clearer view of the difference between both cases:

Fig. 7. Spatial scan at 144MHz (3D).

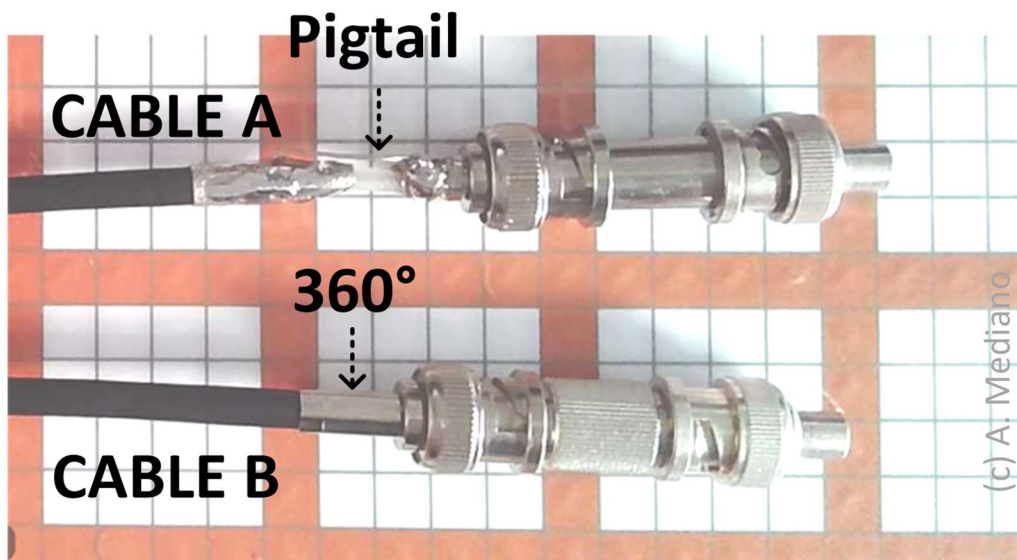
To understand the origin of this difference, the plastic covering was removed from both cables to check for any discrepancies. Indeed, in the case of cable A, the shield of the cable was connected to the connector via a few millimeters of copper wire (pigtail). In cable B, the connection was made (correctly) with a 360° connection around the connector (see Fig. 8):

Fig. 8. Why cables A and B are different.

This issue is common when using low-cost shielded cables in applications like USB, HDMI, etc. A pigtail connection poses a significant risk (and is often invisible to the user).
