# Y.I.C. Technologies

## Comprehensive Application Note

### Finding EMC leakage in cables and connectors

April 2024

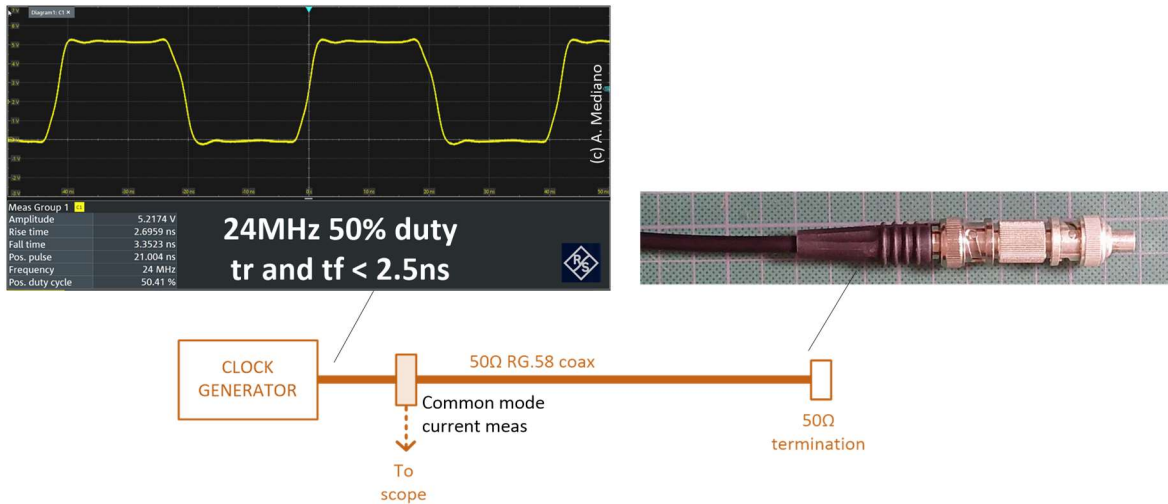
Fig. 2. Details of the setup.

For the test, the common-mode current in the cables was measured using an R&S EZ-17 current probe and a R&S RTO6 scope (see Fig. 2). The cable termination is 50 ohms with a 360-degree connection to the cable connector.

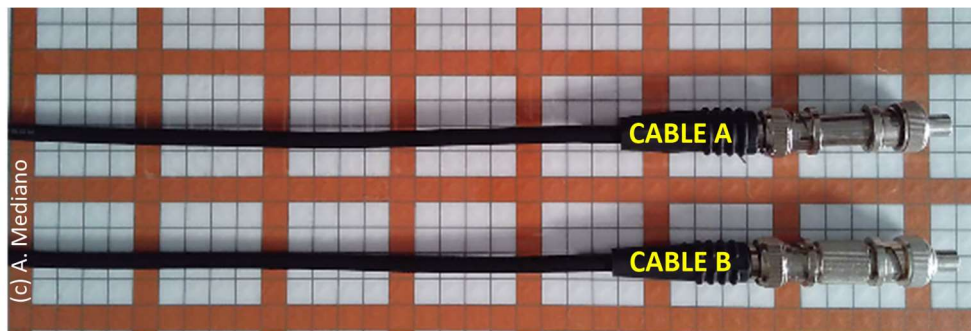
*Fig. 4. The two tested cables on the EMScanner.*

To analyze the situation, both cables were tested using the same signal with the YIC Technologies EMScanner. As depicted in the figure, the results of the analysis were compared between two "identical" cables using the same clock signal.

It is important to highlight that visually, both cables appear to be identical, so it is not possible to infer where the problem lies through visual inspection alone.
